“Bridging Cracks”

Vinton, Iowa
2008

AlphaGen Coatings R&D Team

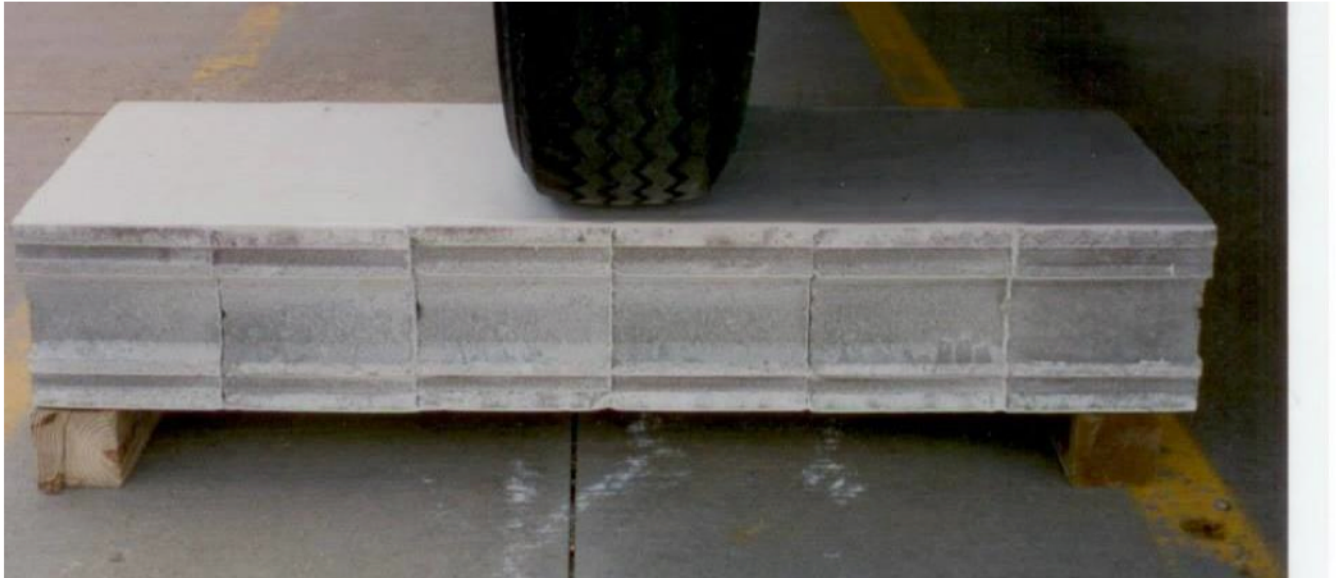
To test the tensile strength of the Cerarmix C-1 coating - AlphaGen took 6 concrete blocks and coating the top and bottom with a thin layer of Cerarmix coatings. Right after the coating had cured, a truck was placed on top of the coated blocks where it stayed for a couple weeks. When the truck was removed from the coated blocks, no cracking or breakage came from this, showing the strength that even such a thin layer could hold such weight for so long with NO adverse effects.
